*Safety Soapbox*  
***Bodgey Scaffold of the Week***

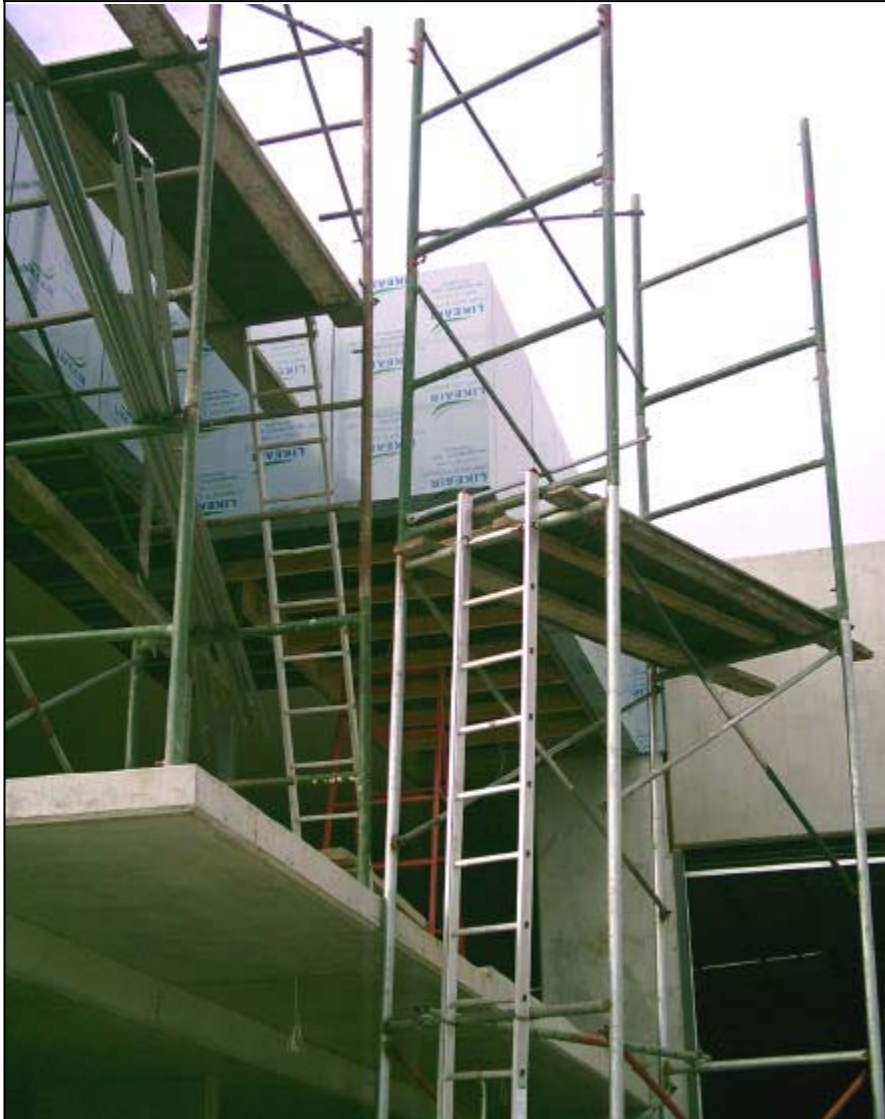
The closer you look, the worse it gets. Rather than use a genuine scaffolding system, this contractor has used formwork shoring frames to construct scaffolds. The lower lifts of the scaffold on the right seem to consist of a couple of home-made double-lift end-frames.

A shortage of genuine scaffold planks has been “overcome” by using a few lengths of timber and some ply sheets. Edge protection, to the scaffold platforms and the suspended floor slab, is non-existent. Using a vertical ladder as access to a scaffold is dangerous, and therefore unacceptable. (When placed correctly, at a slope of between 1 in 6 and 1 in 4, an access ladder should also extend at least 900 mm above the platform.)
